Solid oxide fuel cell redox instability characterized by *in situ* transmission electron microscopy

Q. Jeangros^a, A. Faes^{a,b}, J. B. Wagner^c, T. W. Hansen^c, R. Dunin-Borkowski^c, J. Van herle^b, A. Hessler-Wyser^a

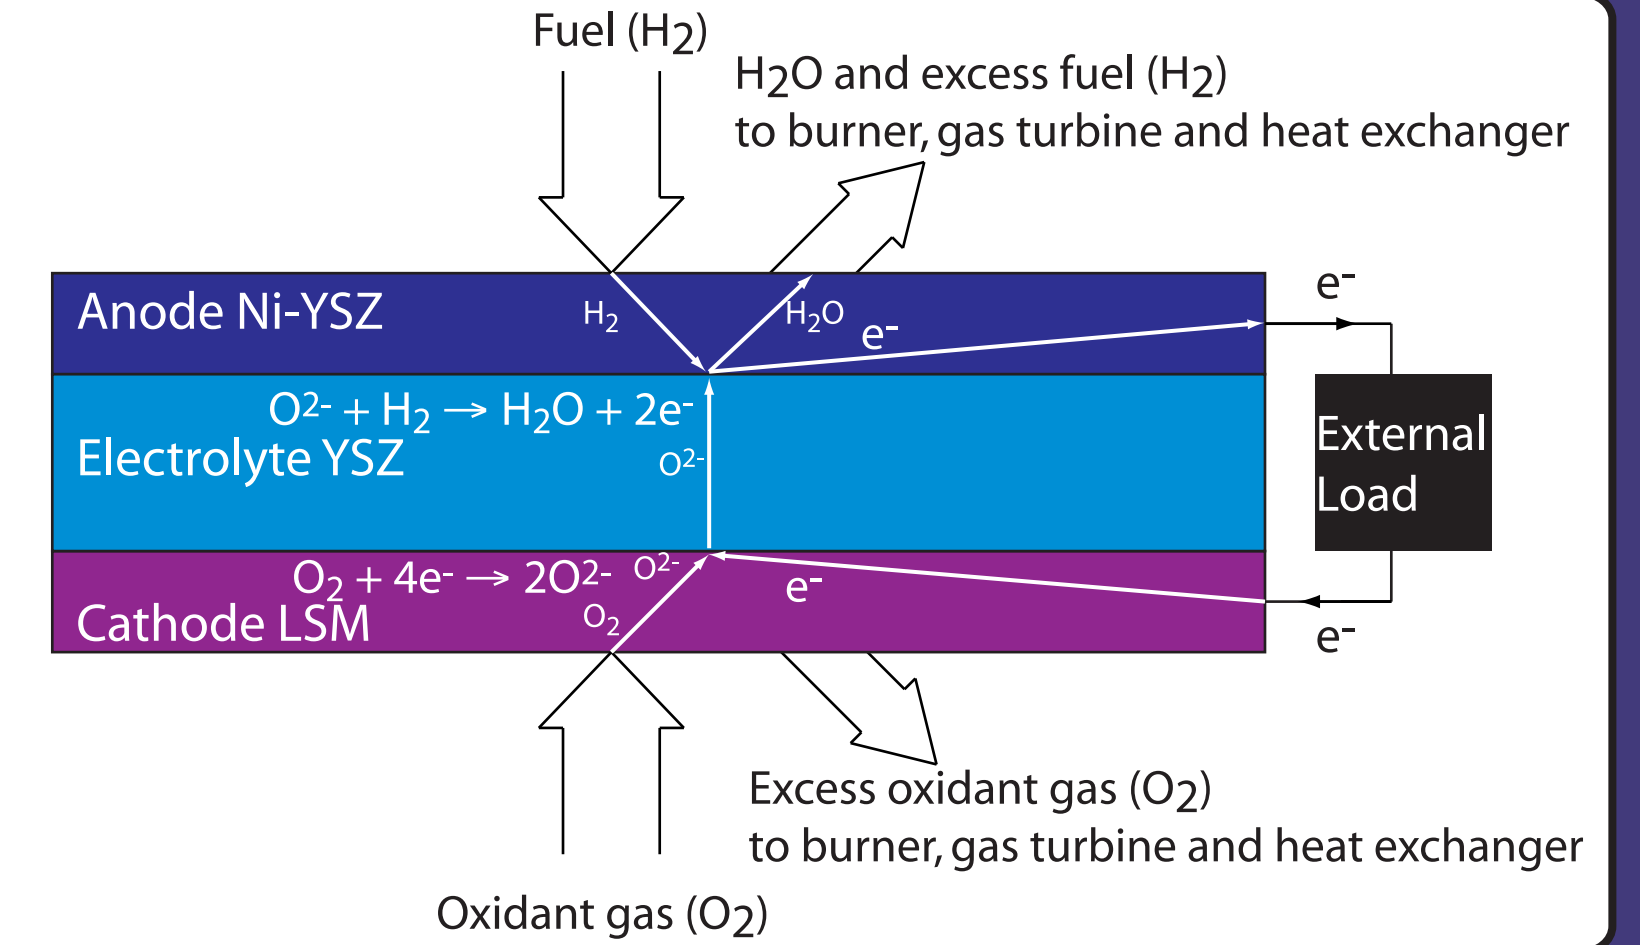
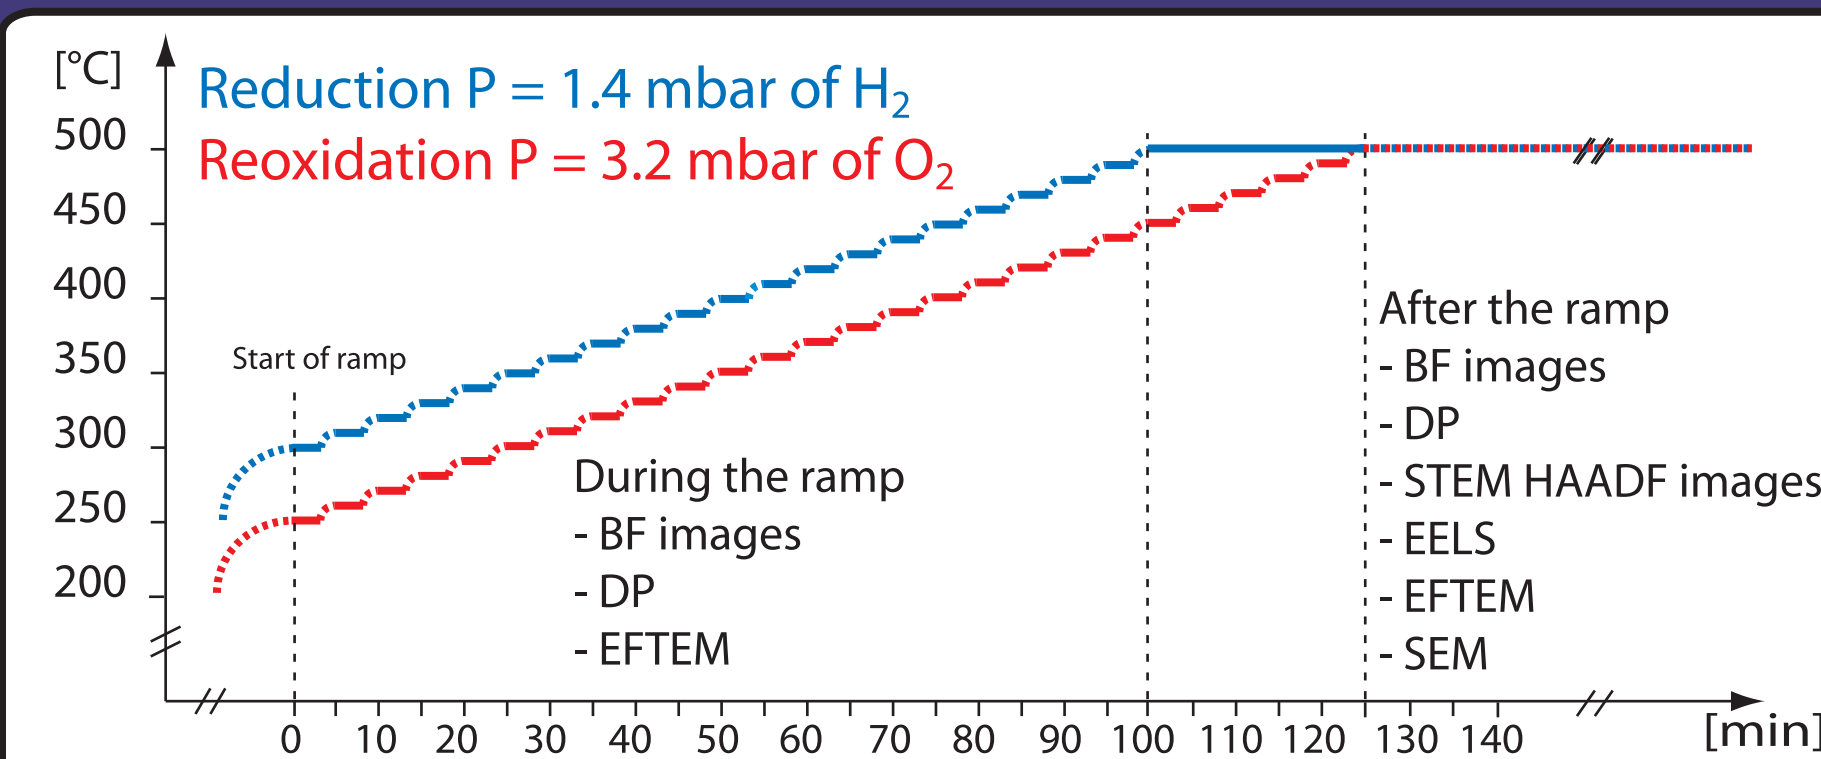
The NiO-YSZ cermet was reduced *in situ* during a temperature ramp from 300°C to 500°C under a partial pressure of 1.4 mbar of H_2 in an environmental microscope FEI TITAN E-CELL™ at the Center for Electron Nanoscopy, Technical University of Denmark. Differential pumping apertures allow *in situ* S/TEM gas experiments to be performed.

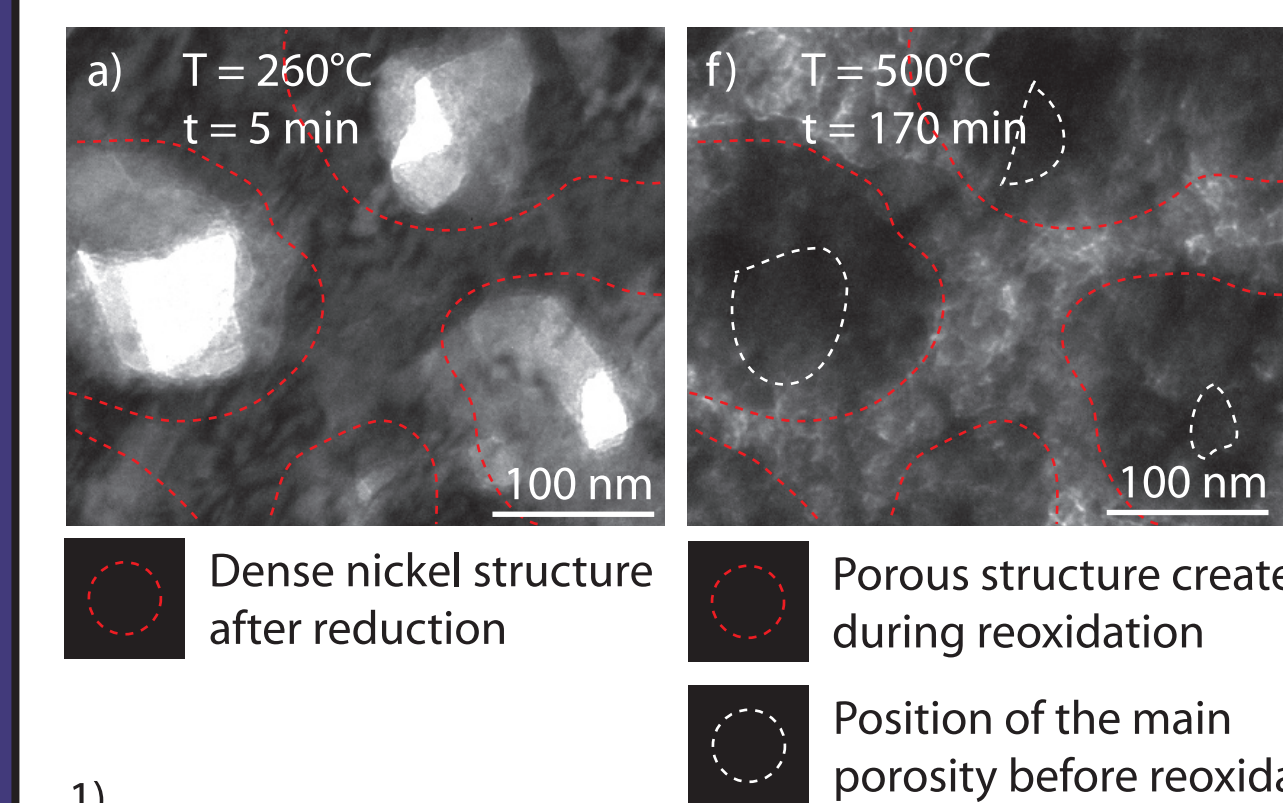
Outward diffusion of Ni^{2+} through the oxide grain boundaries/dislocations is the dominant mass transport mechanism <1100°C.

Inward diffusion of O_2 through dynamically created and resealed fissures.

There is no balance between the two mechanisms: a porous reoxidized structure is created.

Nickel expands into as-sintered pores upon a redox cycle.

- Growth of NiO crystallites. Accumulation of vacancies at the NiO/Ni interface as voids due to outward diffusion of Ni^{2+} .
- Compressive stress due to oxidation. Buckling of the NiO layer? Local tensile stress caused by the new NiO? Creation of a crack. Permeation of O_2 through the crack.
- NiO fills available space and crack. Vacancies injected at the NiO/Ni interface. Resealing of crack might be faster than void filling, porosity in NiO.
- Continuous formation and resealing of cracks. Porosity in the NiO. Coalescence of voids at the NiO/Ni interface. Porous structure, expansion upon a redox cycle.
